CONDITIONS ASSESSMENT AND RESTORATION PLAN THE SAVANNAH POWDER MAGAZINE

Lominack Kolman Smith Architects | 2019

EXECUTIVE SUMMARY

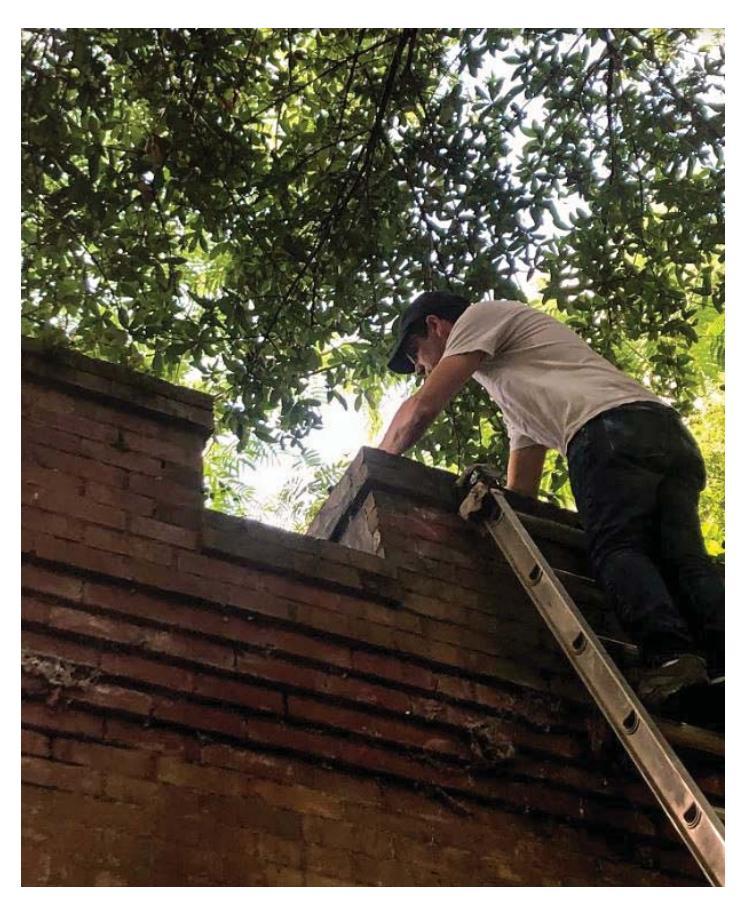
Greg Jacobs of Landmark Preservation, LLC inspecting parapet and roof conditions.

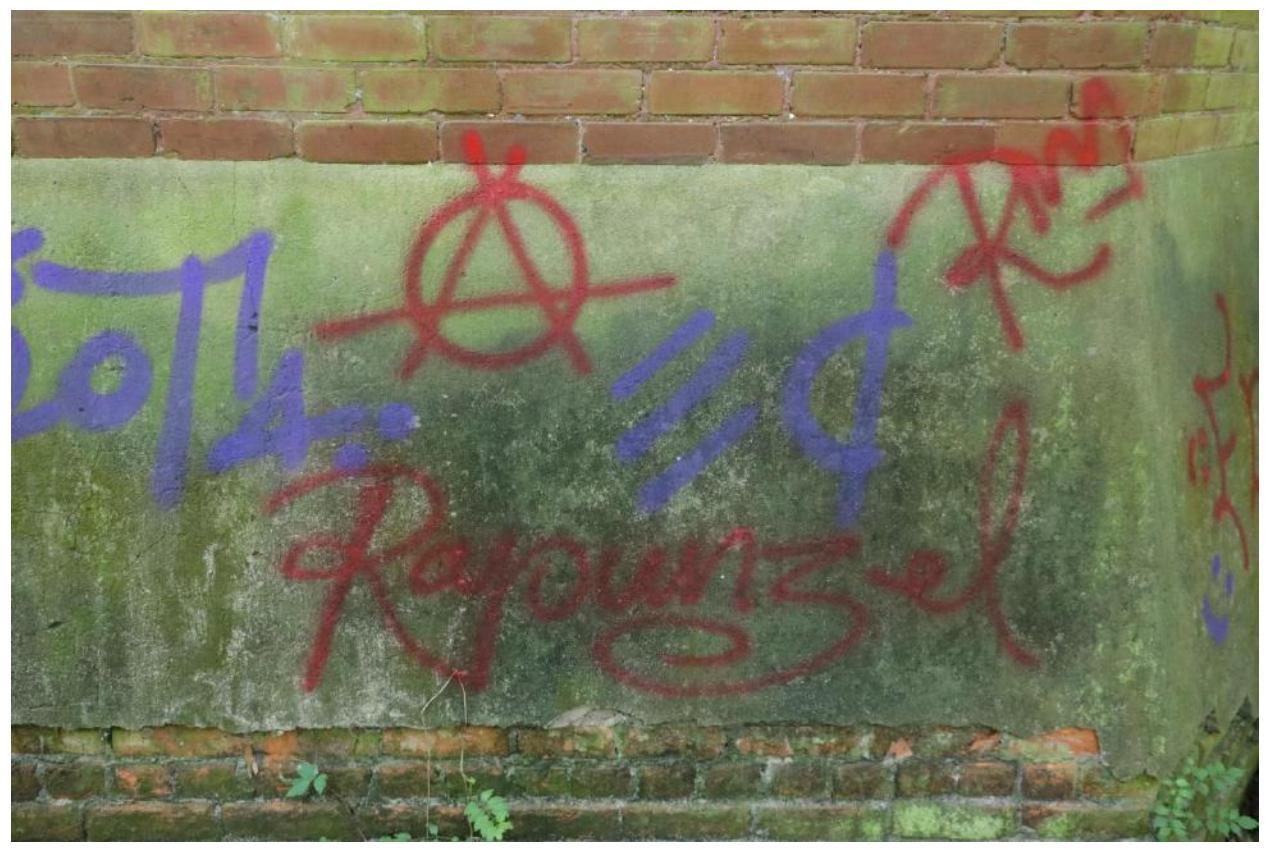
In the summer of 2019, red and purple tinted graffiti was tagged on the Magazine's west facades. Graffiti was put on both the masonry and stucco materials. It appears as though the spray paint used has not penetrated the brick face, however it did penetrate the stucco base material and has caused deep inset stains.

Example of graffiti

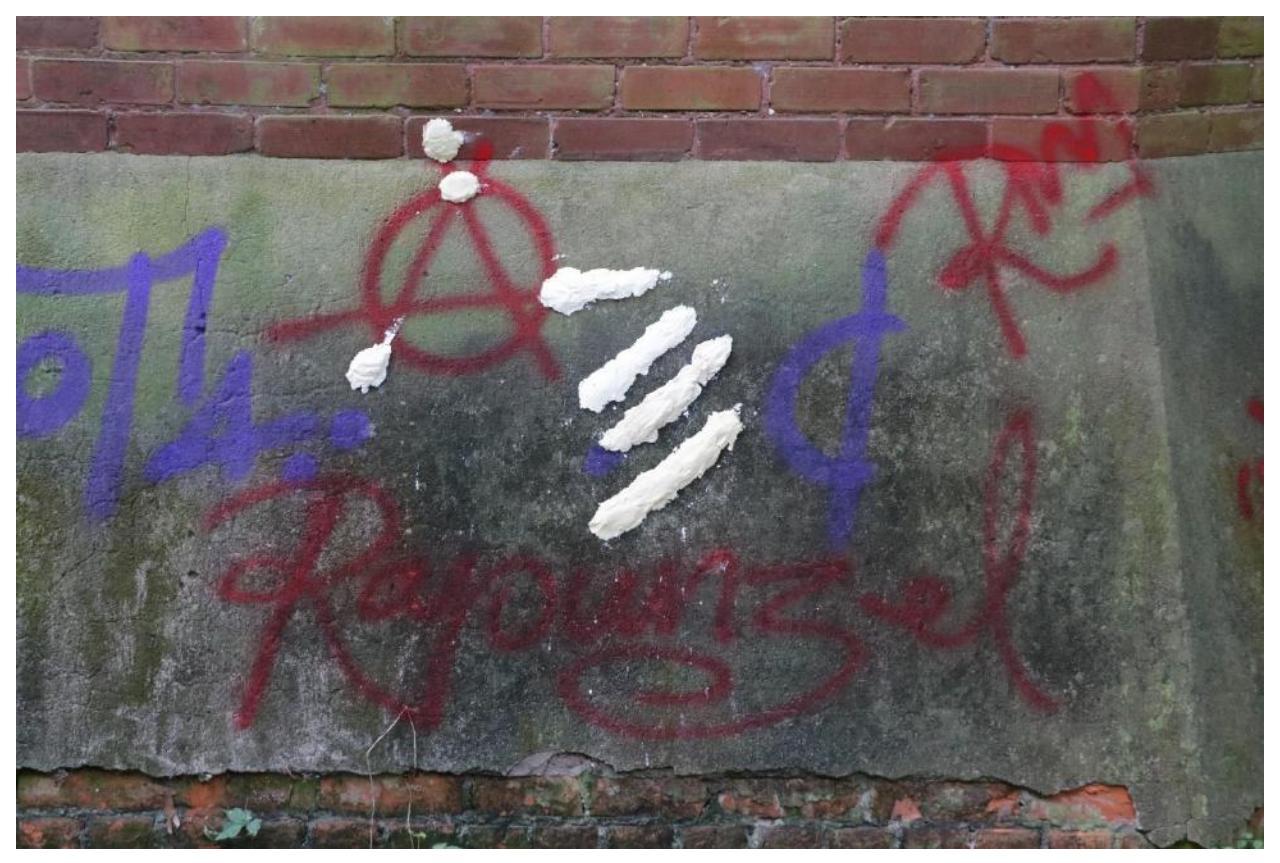
Poultice tests applied to both red and purple graffiti

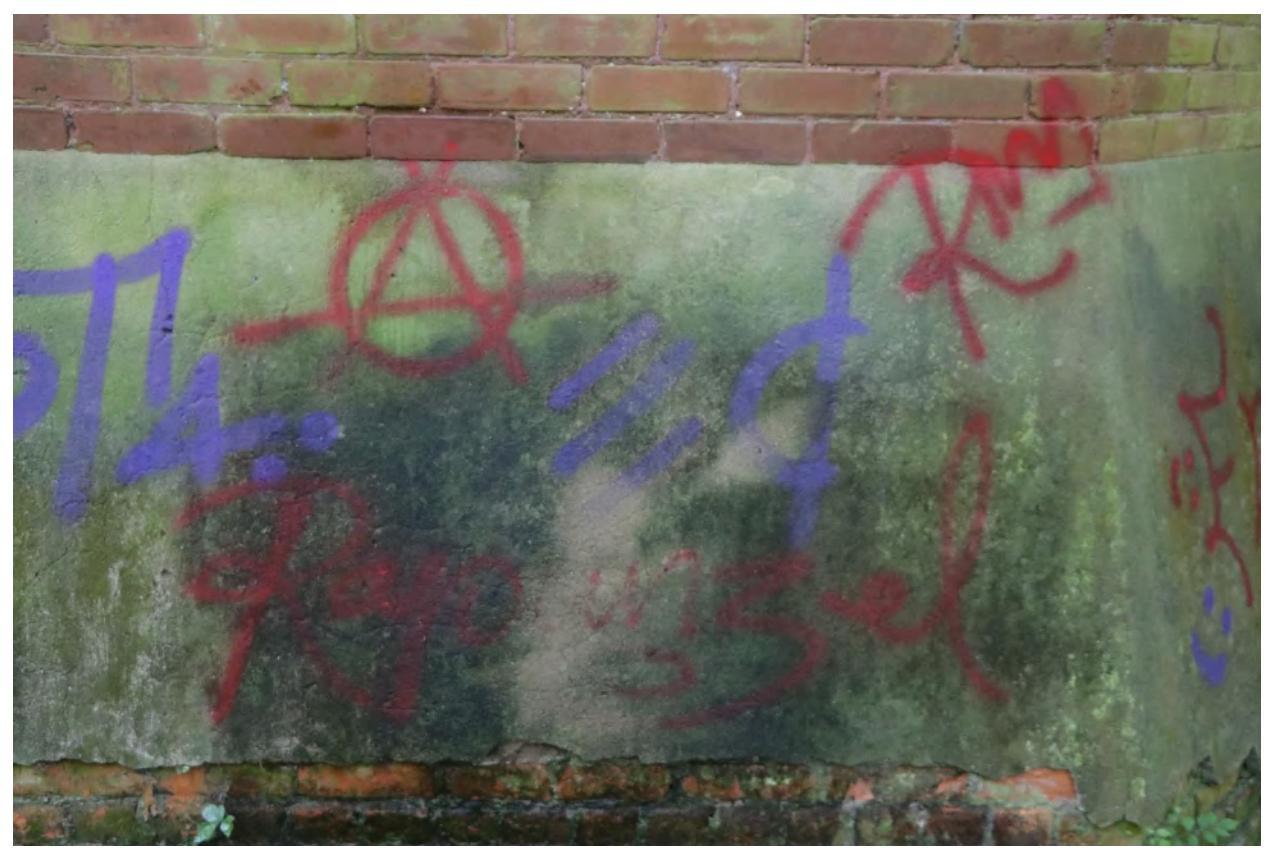
Poultice tests removed and areas scrubbed with water and soft bristle brush

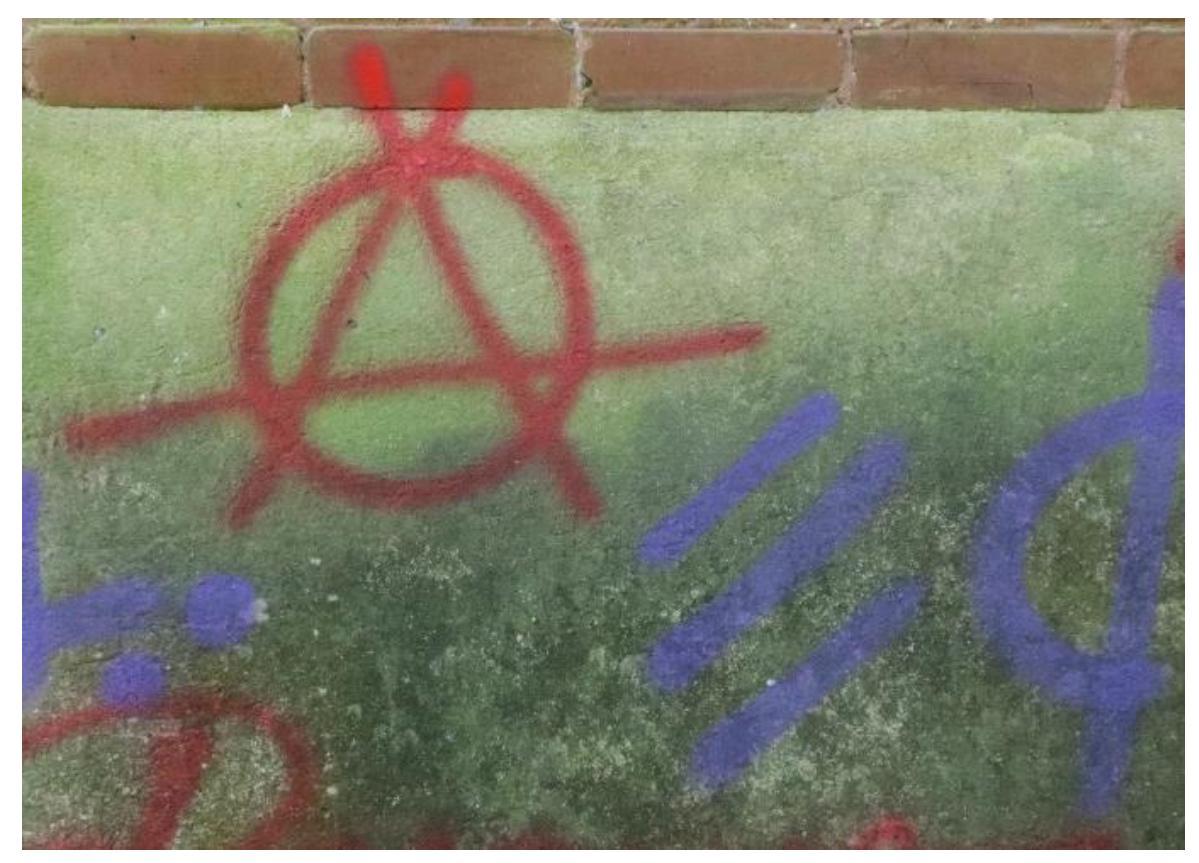
Detail of graffiti before testing

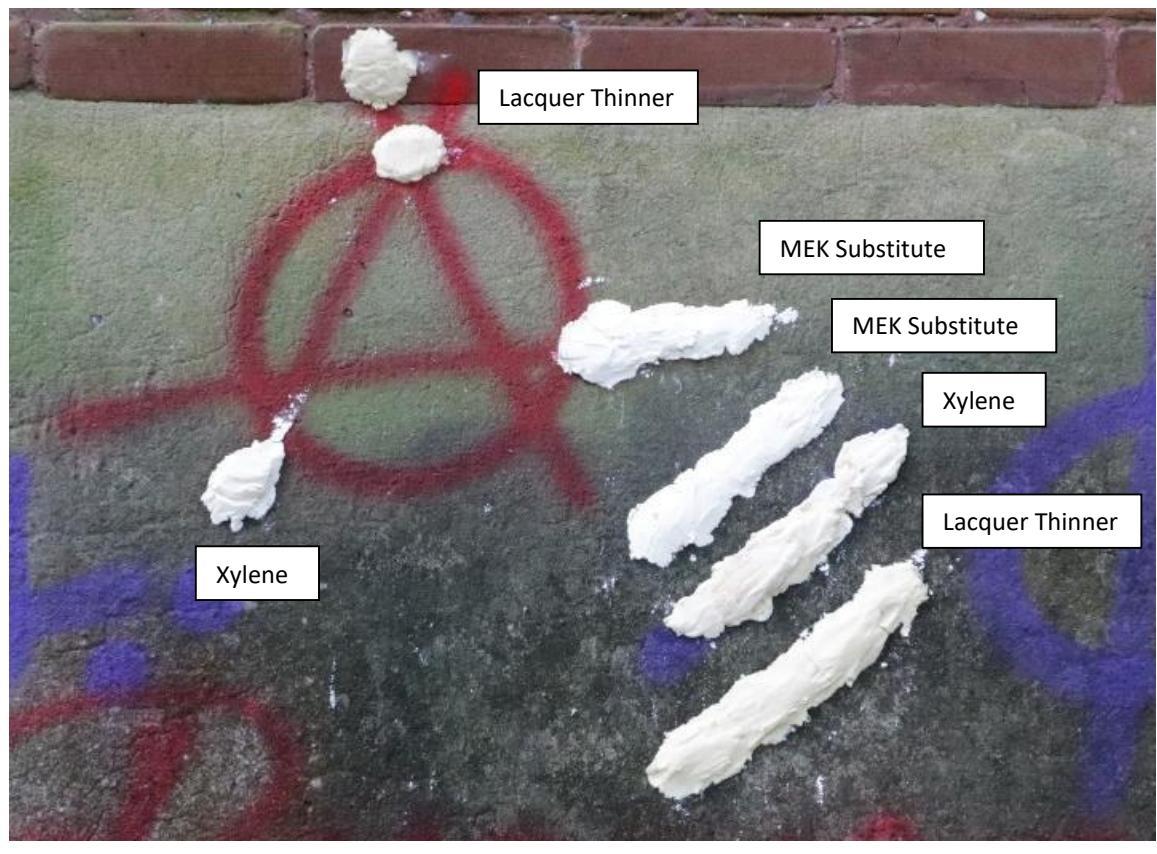
Detail of poultice application

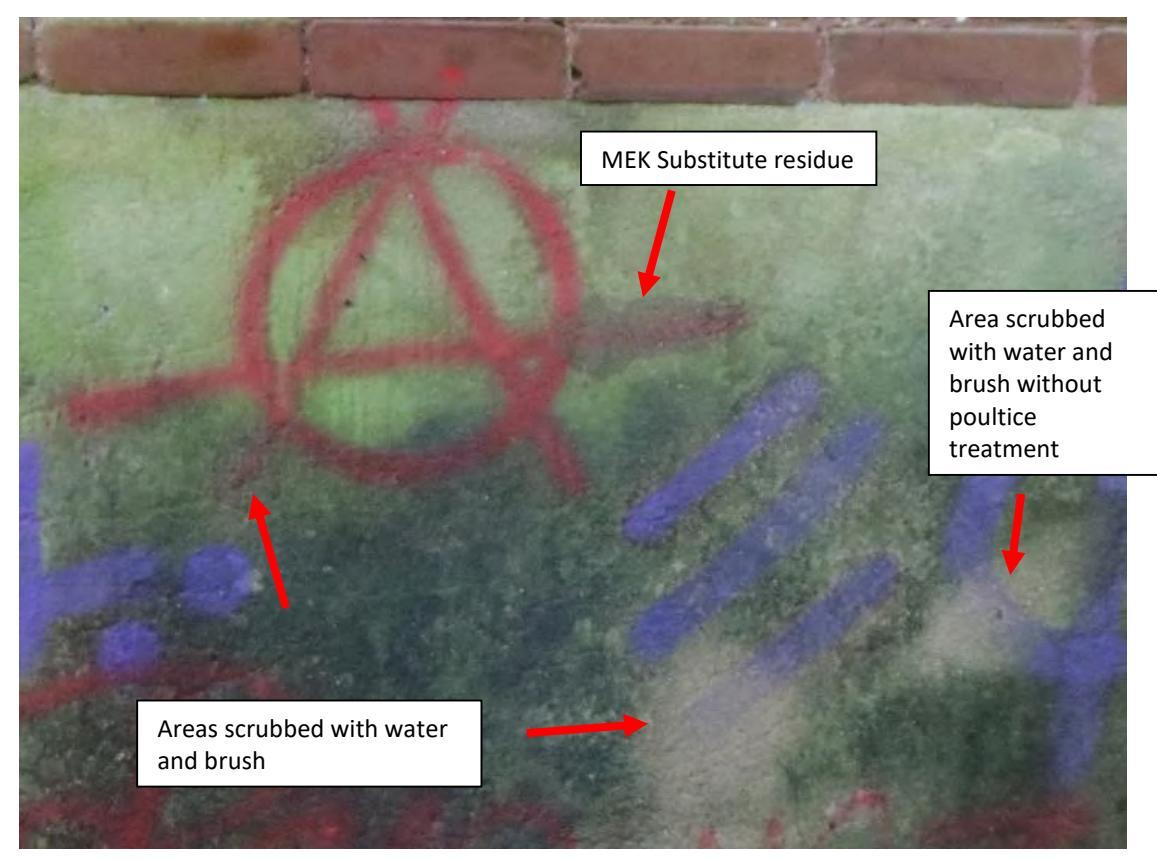
Detail of graffiti after poultice removal and scrubbing with water and soft bristle brush

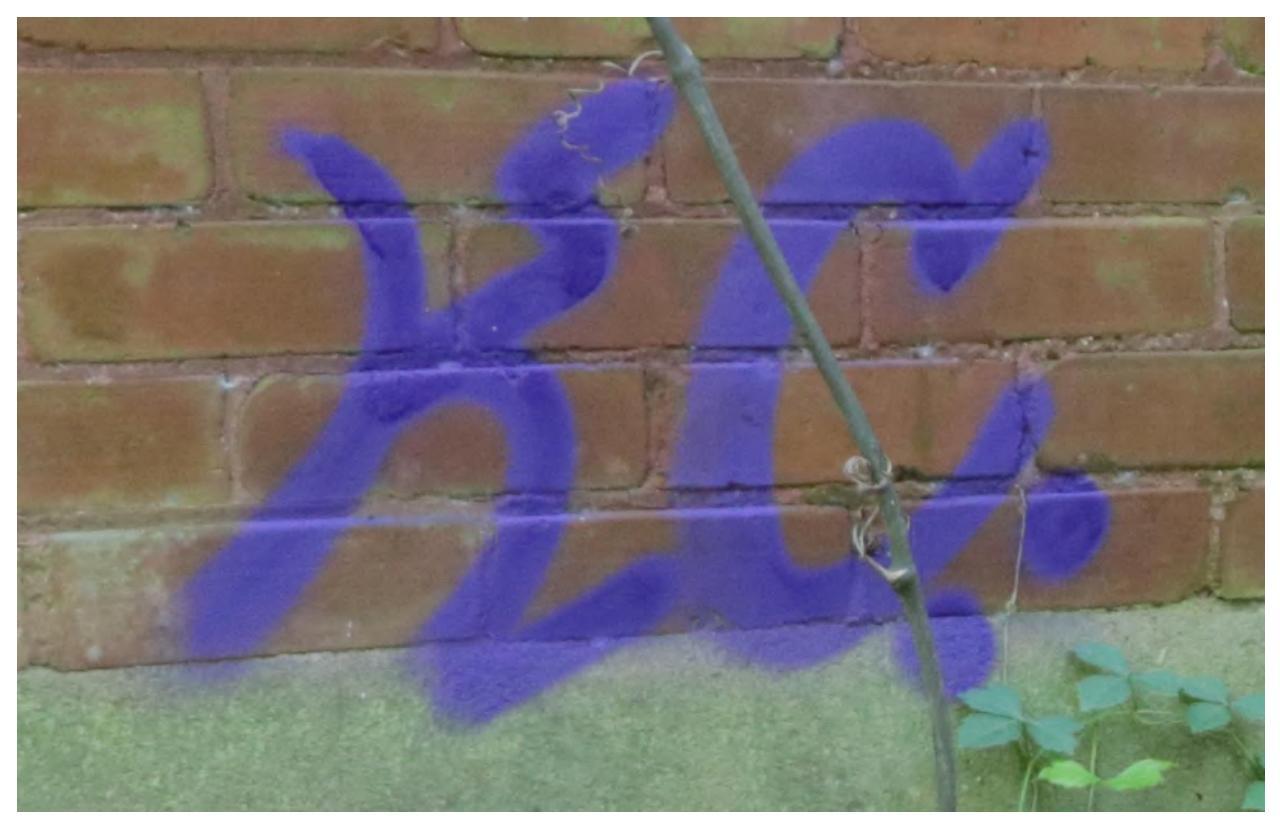
Second detail of graffiti before testing

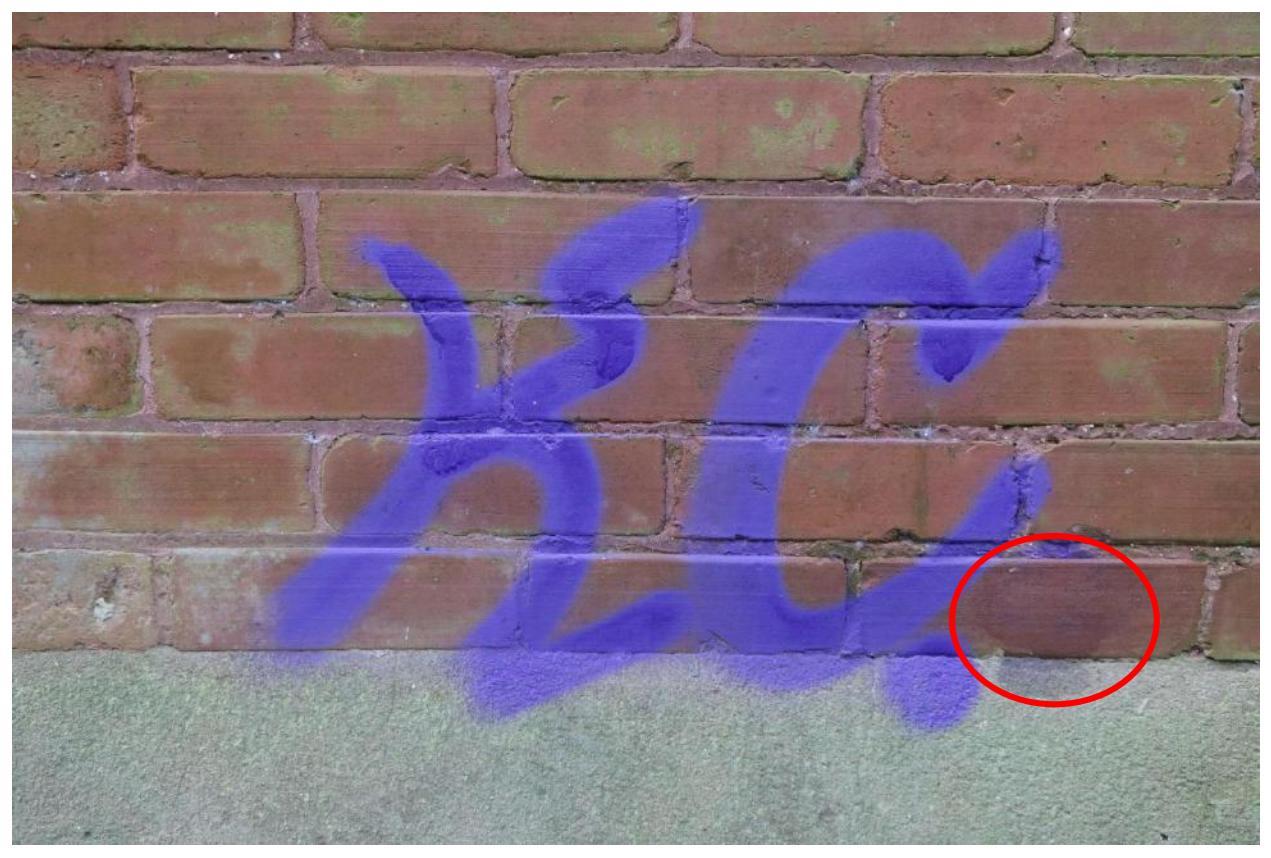
Detail after testing Jasco paint and epoxy stripper

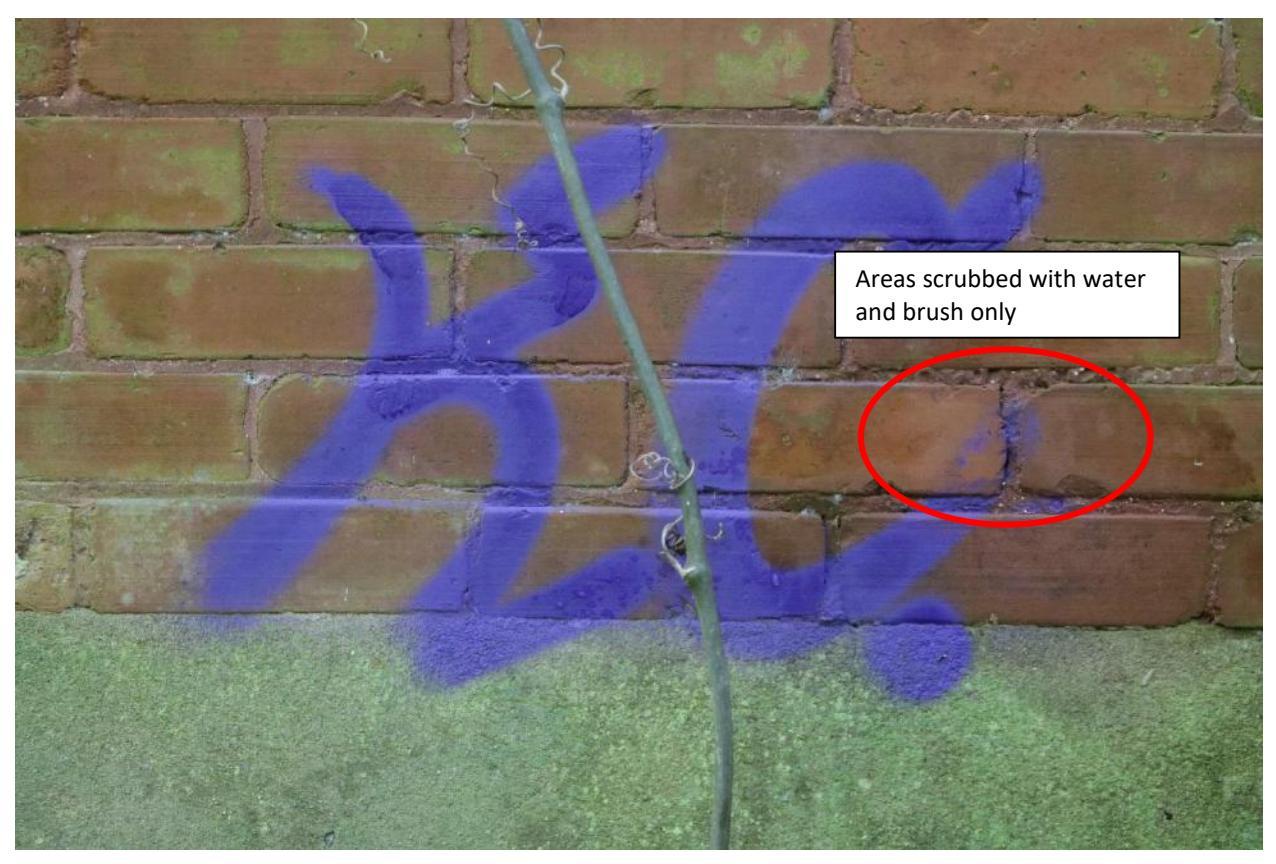
Detail after cleaning with water and soft bristle brush

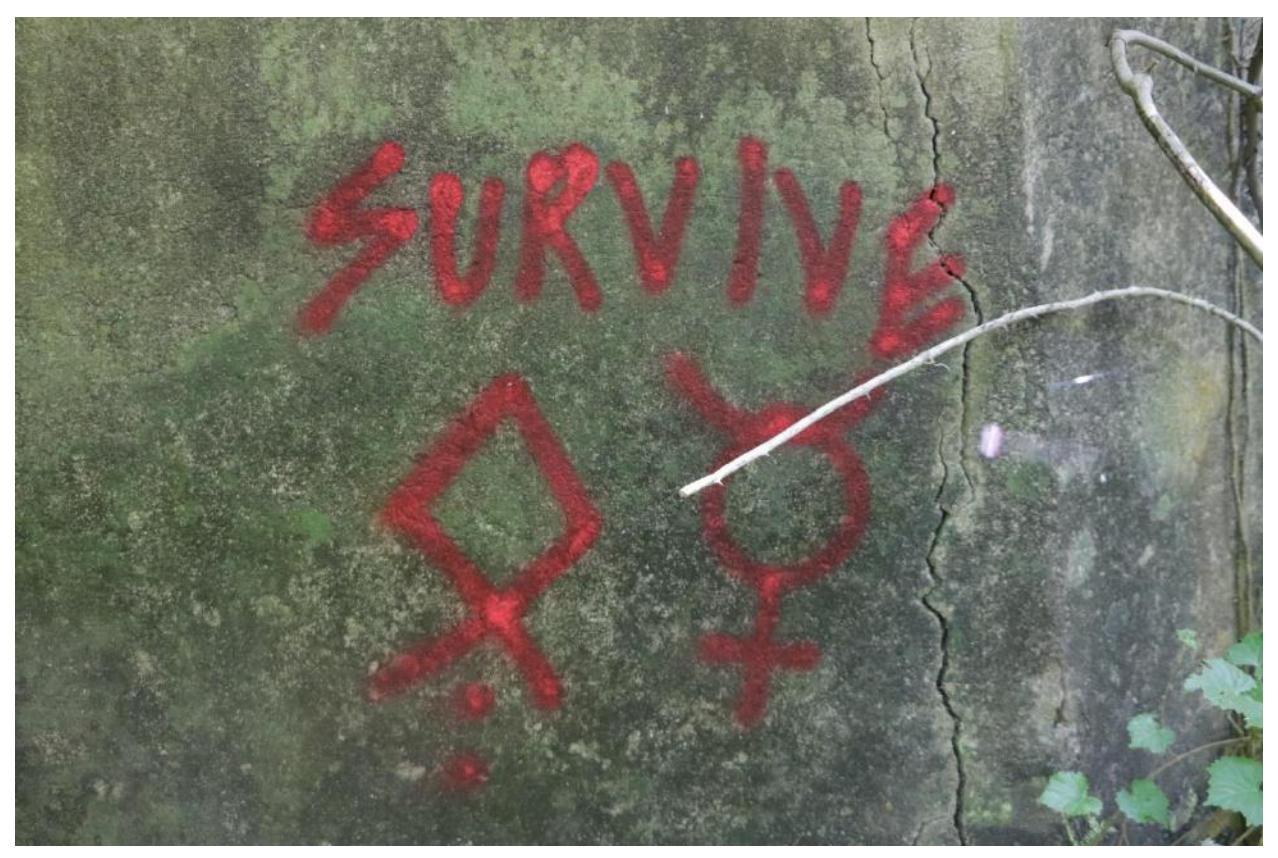
Third detail of graffiti before testing

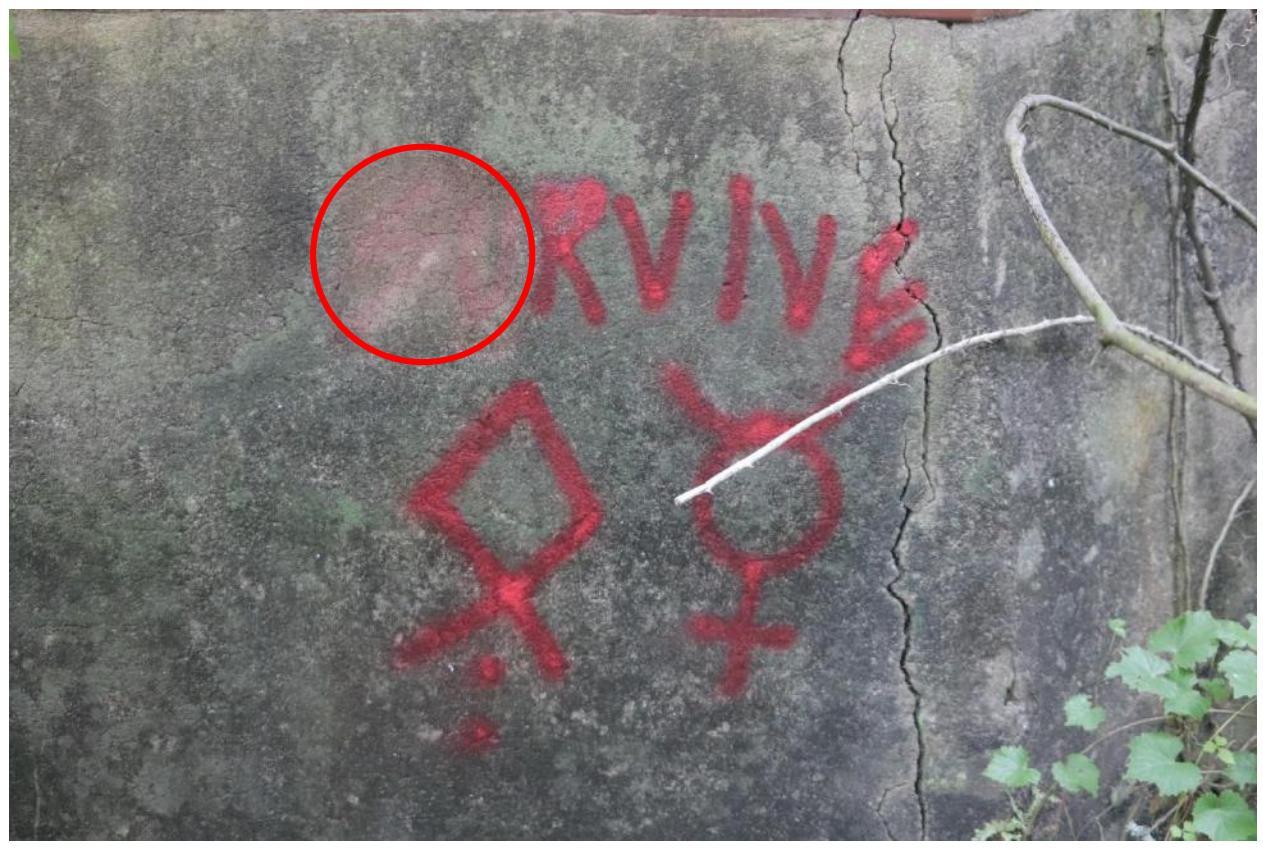
Detail after testing with Jasco paint and epoxy stripper

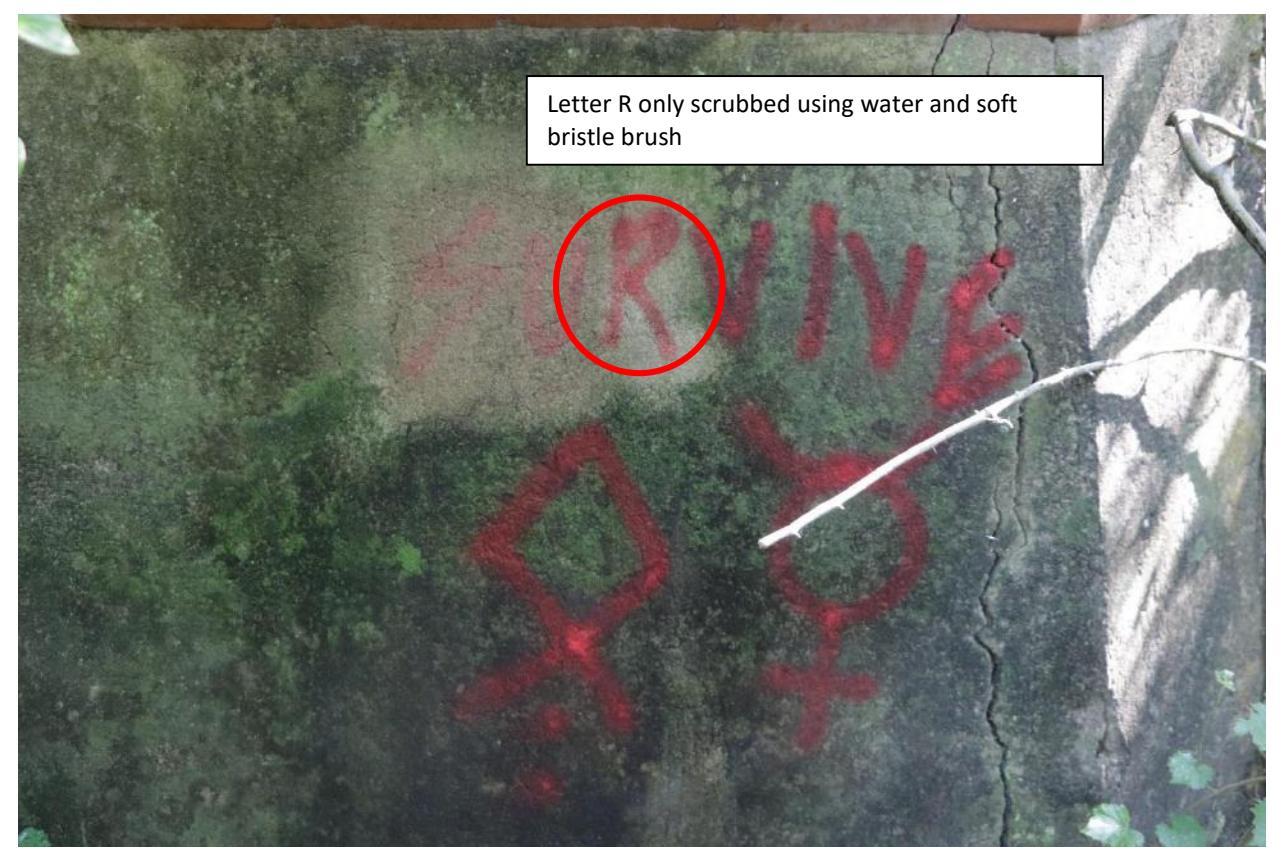
Detail after cleaning with water and soft bristle brush

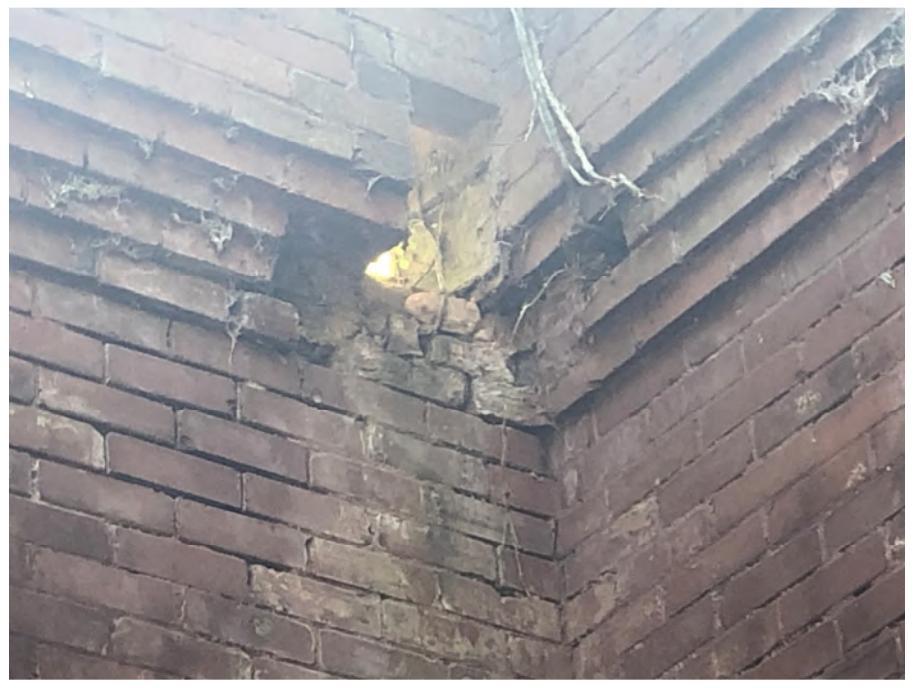
Photo 1: Scupper Location with Missing and Deteriorated Masonry

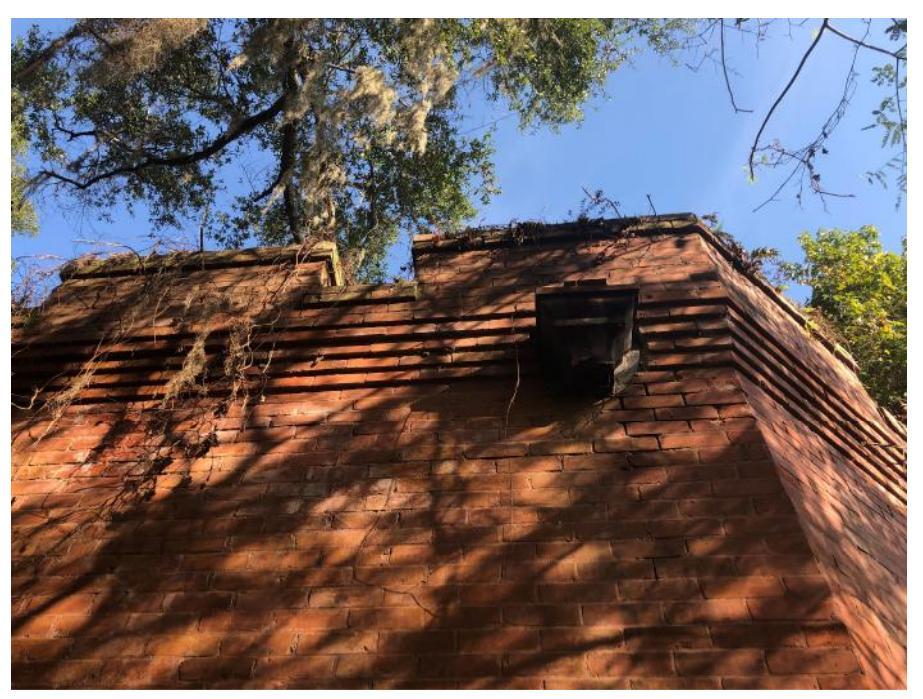
Photo 2: Scupper Location with Deteriorated Mortar Joints

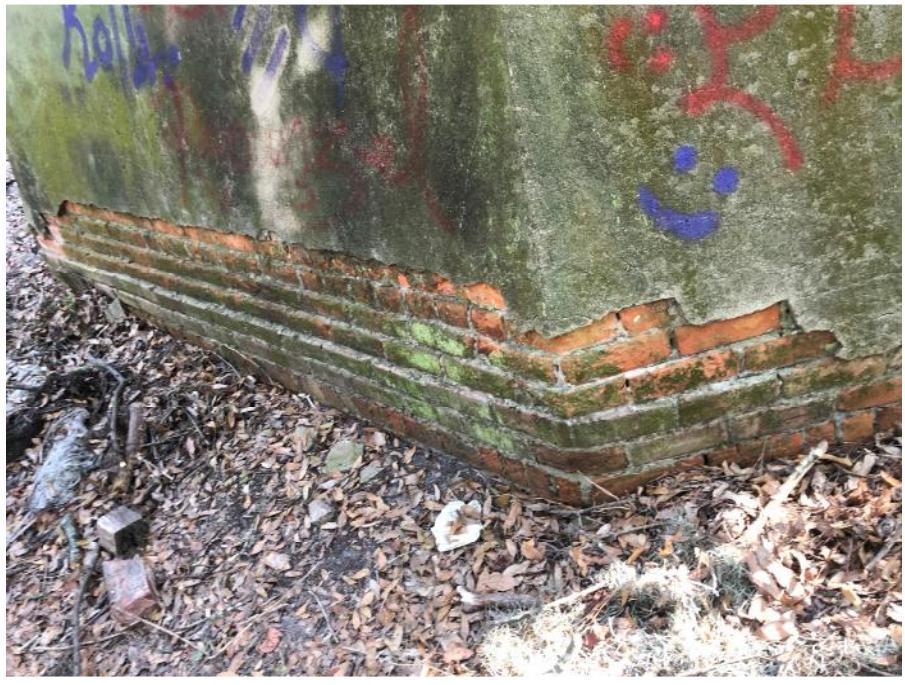
Photo 3: Portland Cement Parge Coating Missing

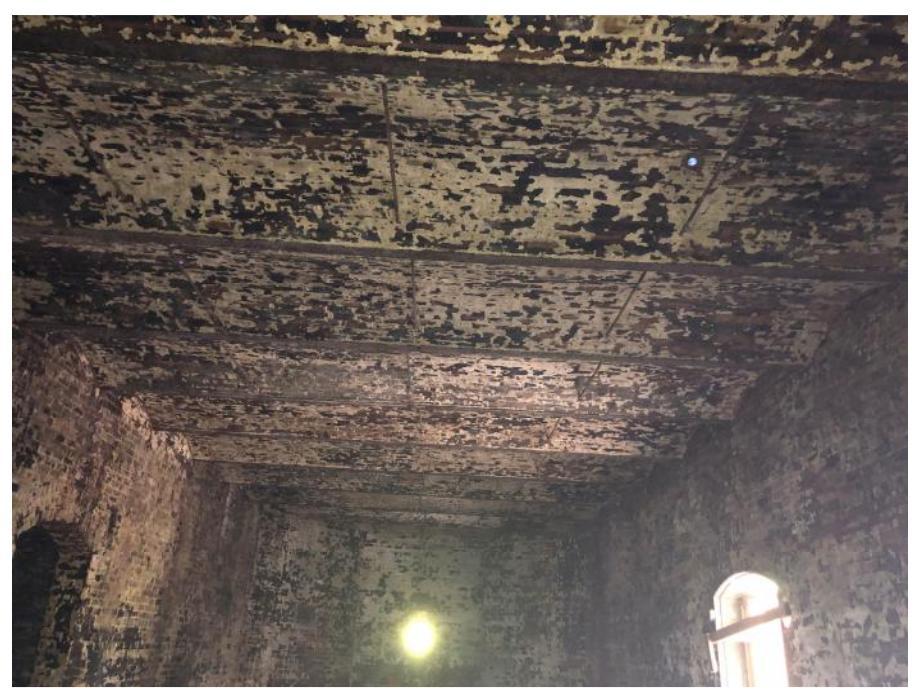
Photo 4: One-Way Masonry Vault and Corroded Steel Roof System

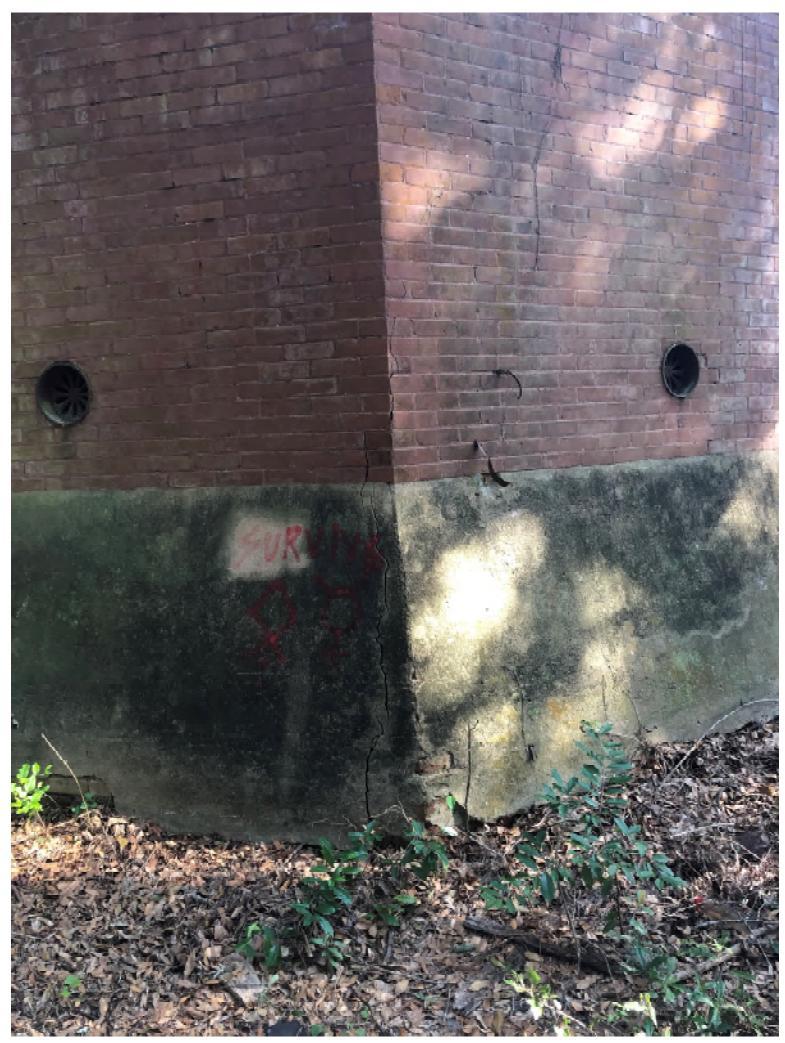
Photo 5: South West Elevation Vertical Crack (exterior façade)

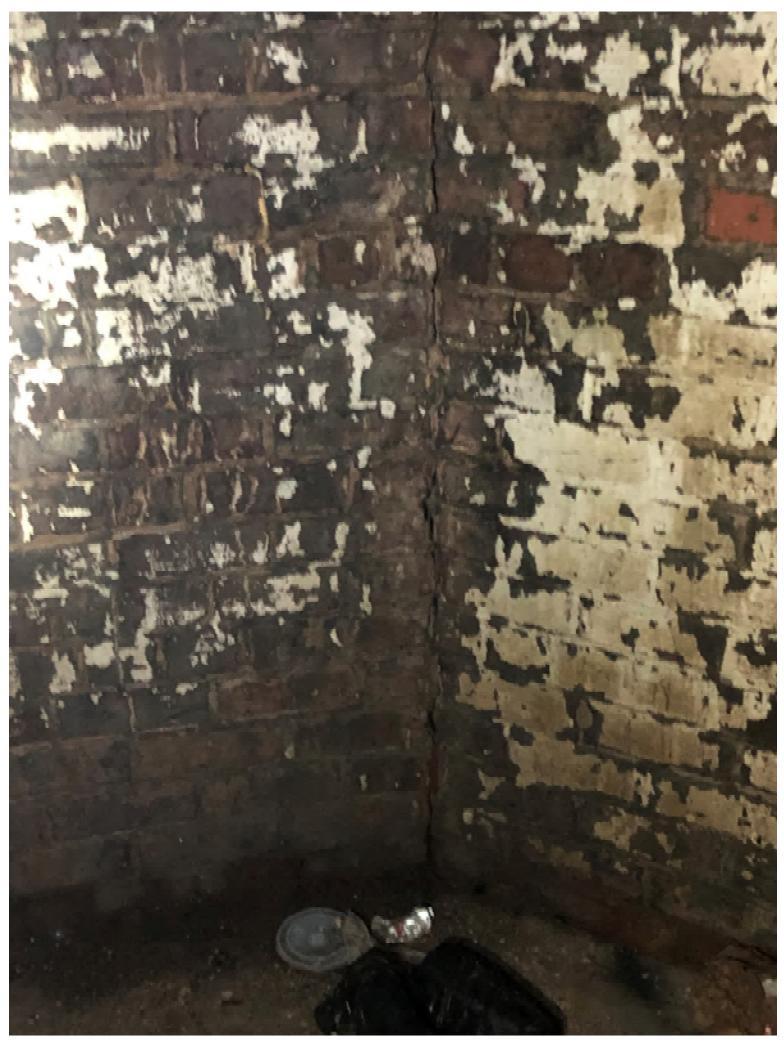
Photo 6: South West Elevation Vertical Crack (Interior)

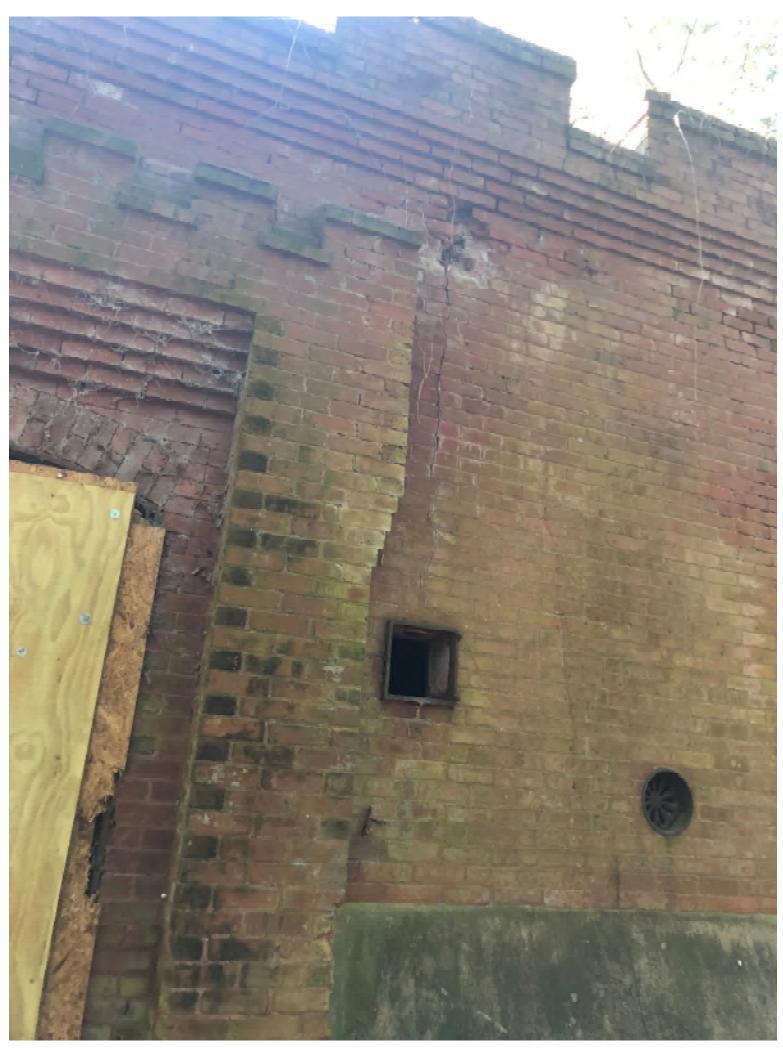
Photo 7: North Elevation – Vertical Crack in Masonry Veneer

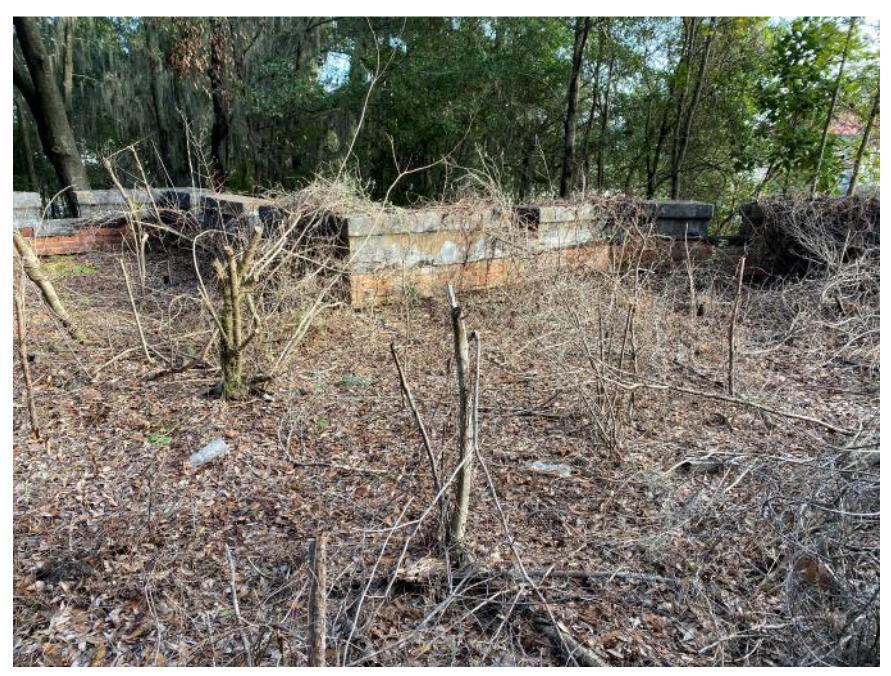
Photo 8: Remaining Plant Growth on Roof

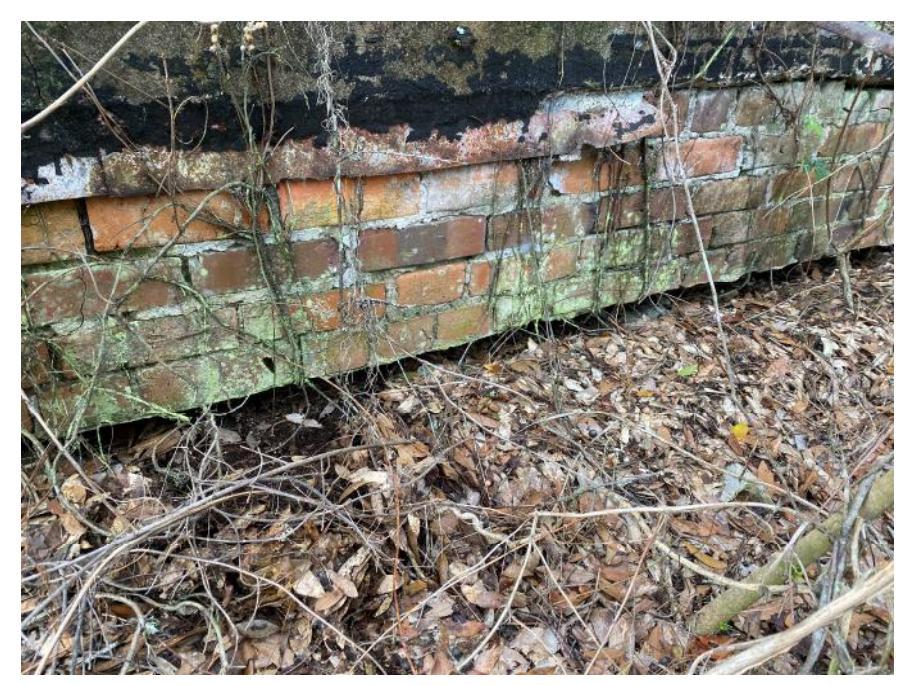
Photo 9: Continuous Framing Pocket at Parapet
