CONDITIONS ASSESSMENT AND RESTORATION PLAN THE SAVANNAH POWDER MAGAZINE

Lominack Kolman Smith Architects | 2019

EXECUTIVE SUMMARY

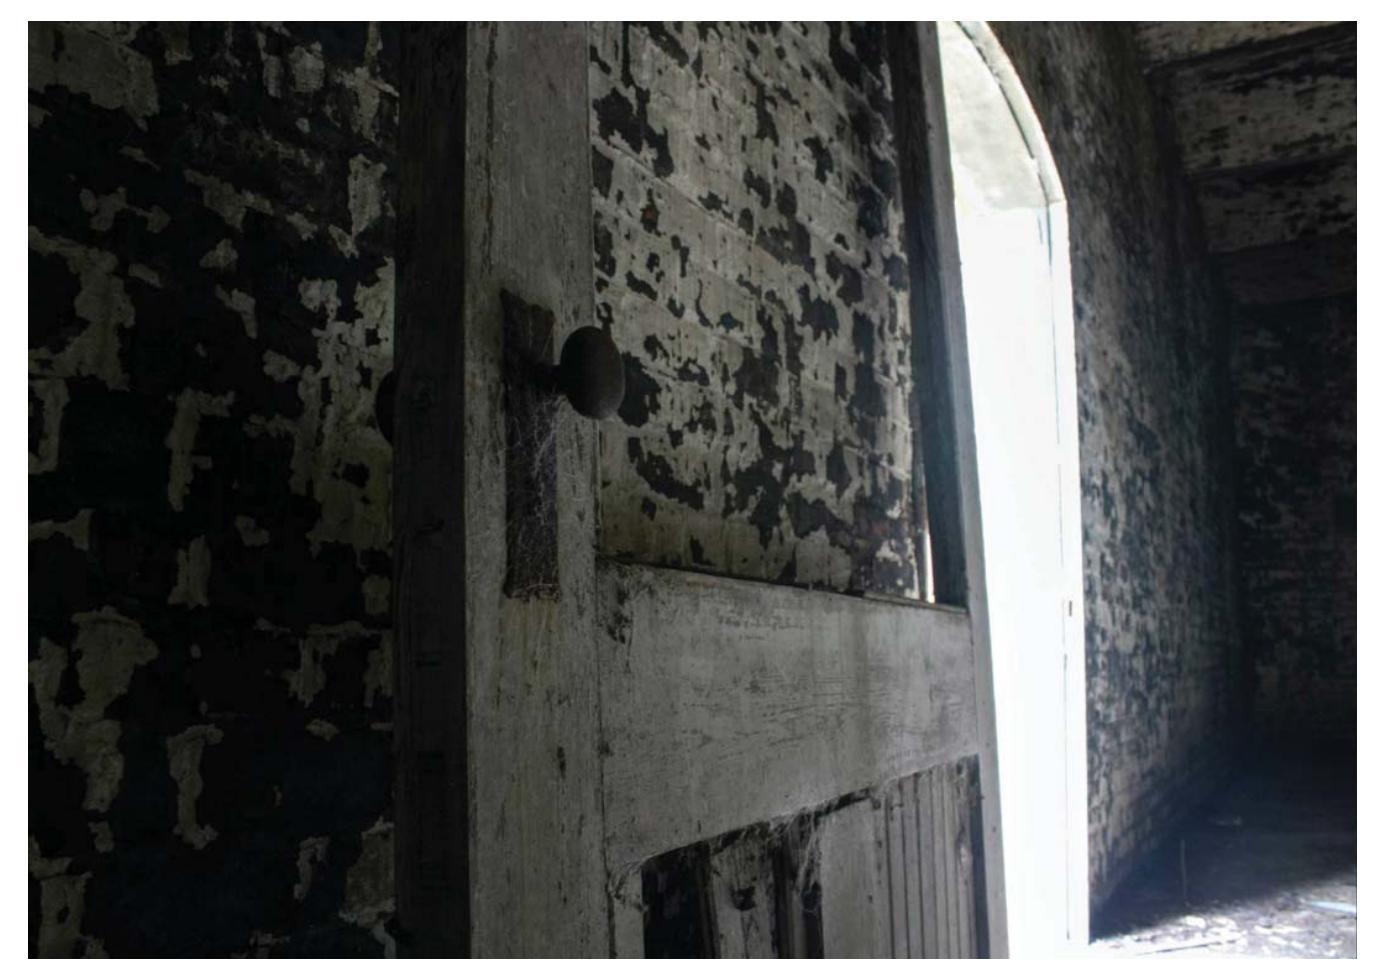
Original interior wood door.

Once the original wood door is able to be assessed, further recommendations can be made as to the means and methods of repair. Once the original wood door is repaired, the missing door should be recreated using the original door as a design template.
